Pedestrian Safety and Mobility Aids for Crossings at Bus Stops

FINAL REPORT
September 2003

One-Jang Jeng, Ph.D.
Research Associate Professor
New Jersey Institute of Technology
Department of Industrial and Manufacturing Engineering
&
George Fallat, P.E.
Deputy Director
New Jersey Institute of Technology
National Center for Transportation and Industrial Productivity

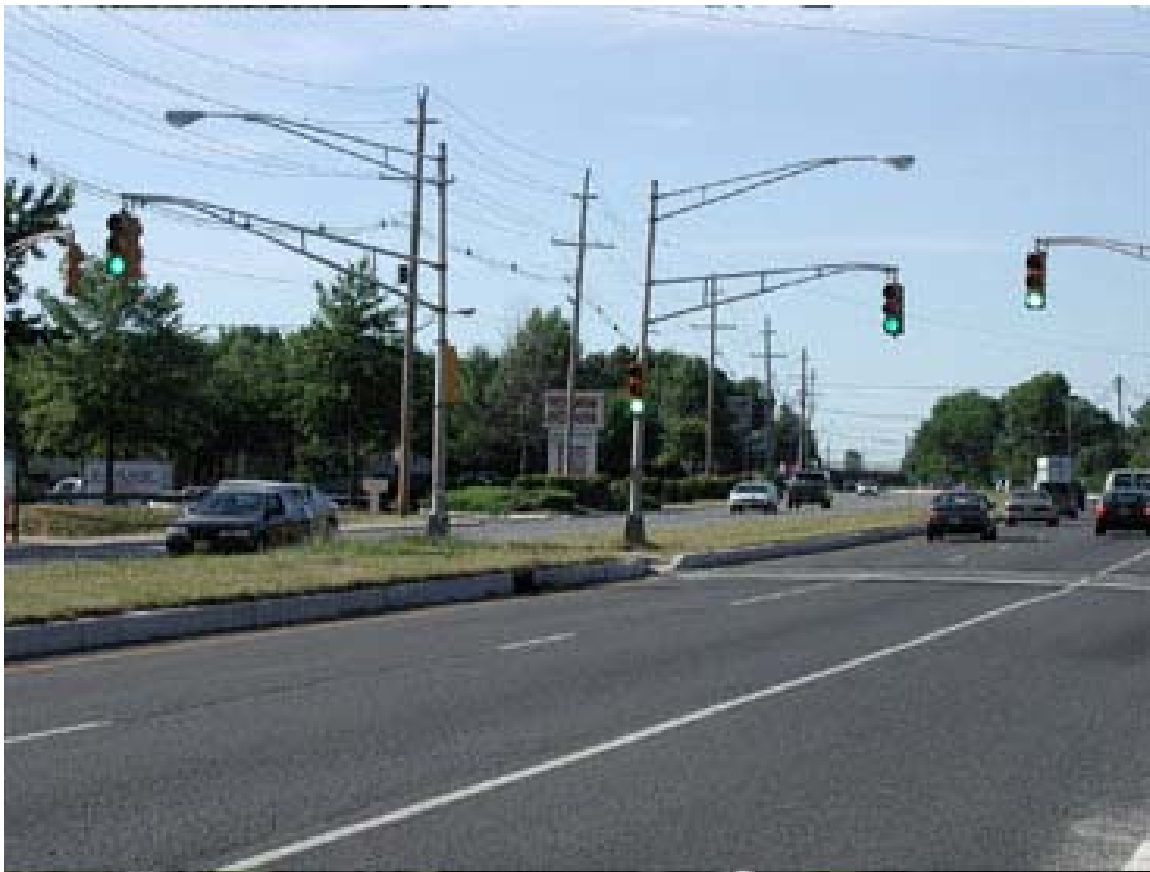
Figure 1. US Route 9. Two lanes with shoulder in each direction divided by grass median.

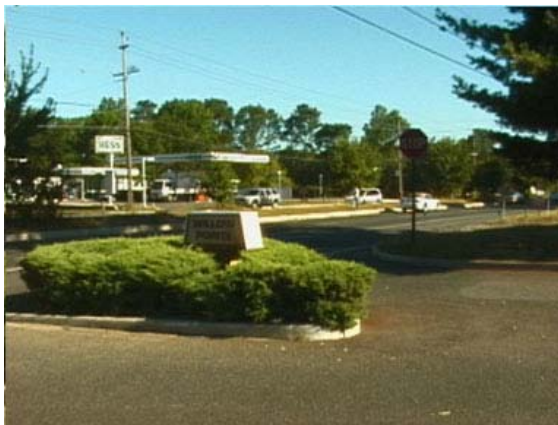
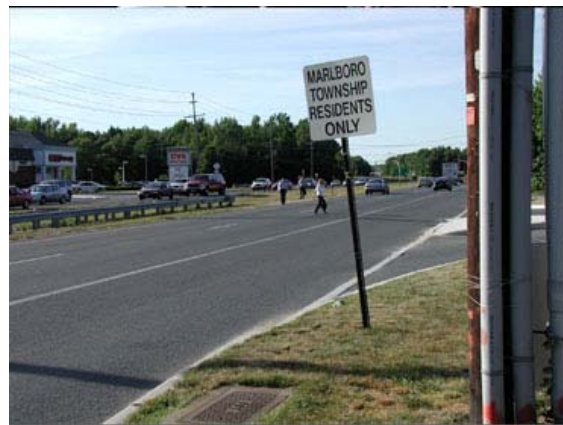
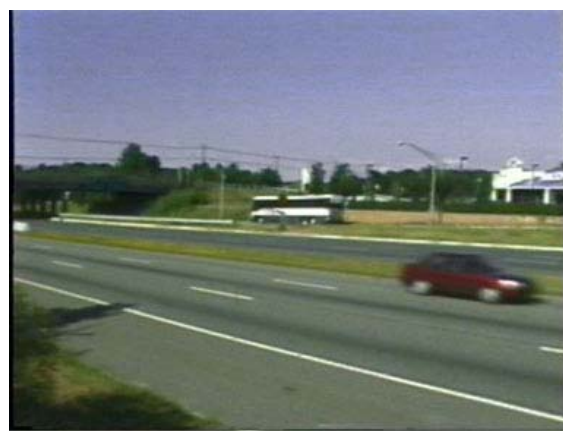
Figure 3. Potential study locations.

Sandburg Drive

Texas Road

Strickland Road

CR 516

Additional field investigations were conducted to determine pedestrian use of each bus stop location (See figure 3). We also studied each location for unique or unconventional crossing behavior. Locations where safety enhancements are already being proposed and/or implemented were eliminated from consideration. Based on the results of our field investigations, Strickland Road and Texas Road were selected as the final study locations.

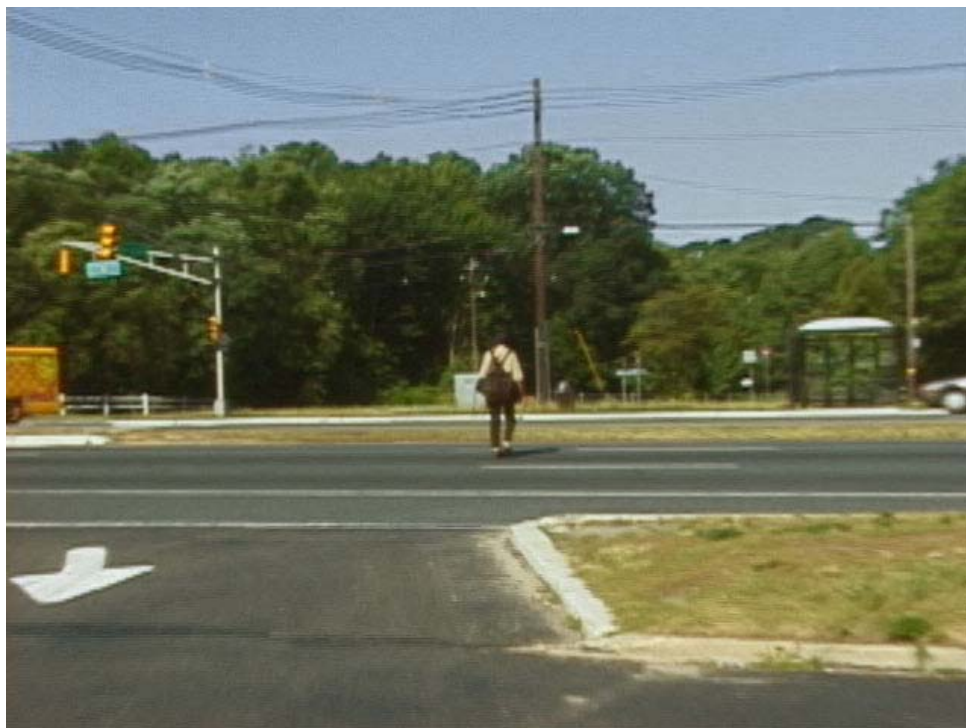
Figure 4. Intersection at Fairway Lane in Old Bridge.

As a follow-up to our field investigations, we also reviewed pedestrian related collisions that occurred along US Route 9 in Monmouth and Middlesex Counties over the past three-year period. The Collision Diagram and Accident Summary are contained in appendix A. We found that a number of serious pedestrian related accidents occurred at the intersection at Fairway Lane in Old Bridge Township (See figure 4). Hence this location was added to our list of study sites only for conducting driver evaluation for measures to enhance pedestrian safety and mobility. Due to the observed lack of use and probable survey participation, the team decided not to administer the survey/questionnaire at Fairway Lane. However, an evaluation from the driver's perspective was conducted for this location.

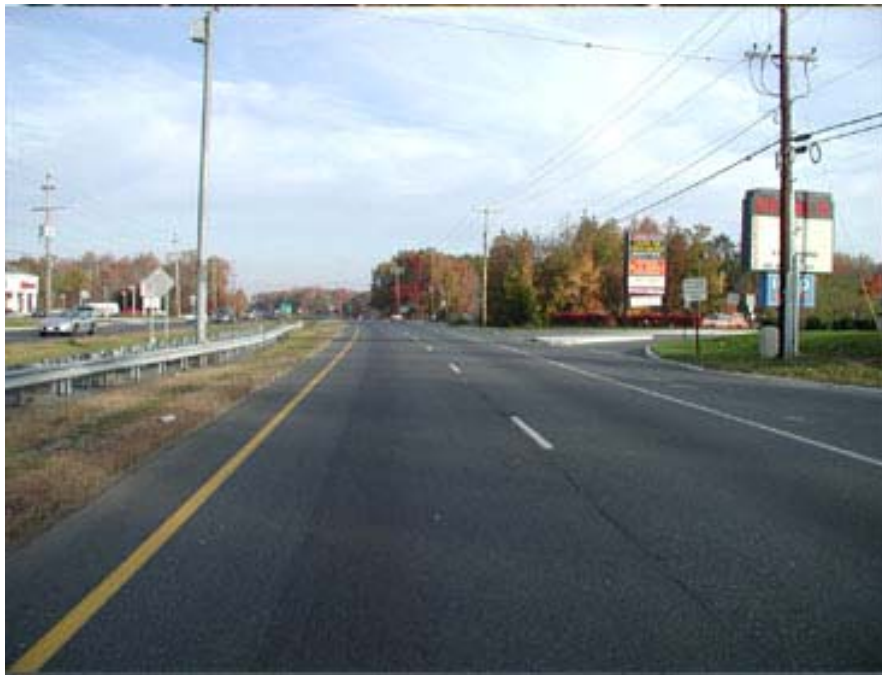
Figure 6. Texas Road location

Bus stops are located within close proximity of the Texas Road and US Route 9 intersection (see figures 6 and 7). On the northbound side of US Route 9, an existing shopping center parking area serves as a park and ride lot. A bus shelter is provided approximately 500 feet south of Texas Road and a bus pull off is provided on the northbound US Route 9 shoulder. For the southbound direction, the bus pulls off the traveled way onto the existing shoulder approximately 200 feet south of Texas Road. No shelter is provided for this direction. The northbound direction experiences the heaviest use during the morning hours.

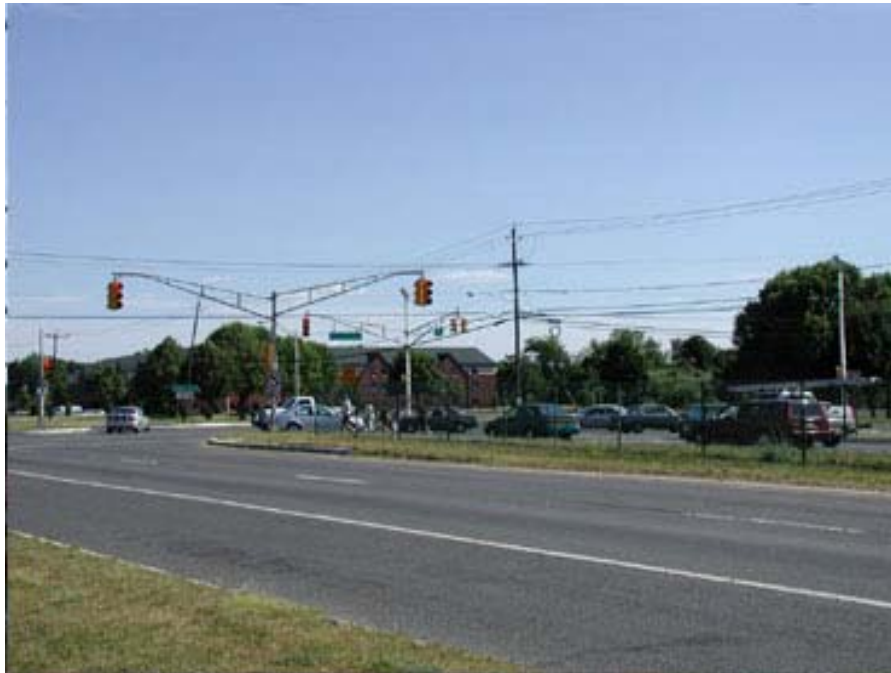
Figure 9. Strickland Road Location

The Strickland Road location has a large park and ride facility with several bus shelters and a large bus pull off area which can accommodate several attending buses at once. These facilities are located on the northbound US Route 9 side. A single bus shelter is provided in the southbound US Route 9 direction and the existing shoulder provides the bus pull off area. (See figures 9 and 10)
