Evaluation of the Blue Bike Lane Treatment used in Bicycle-Motor Vehicle Conflicts Areas in Portland, Oregon

PUBLICATION NO. FHWA-RD-00-150

August 2000

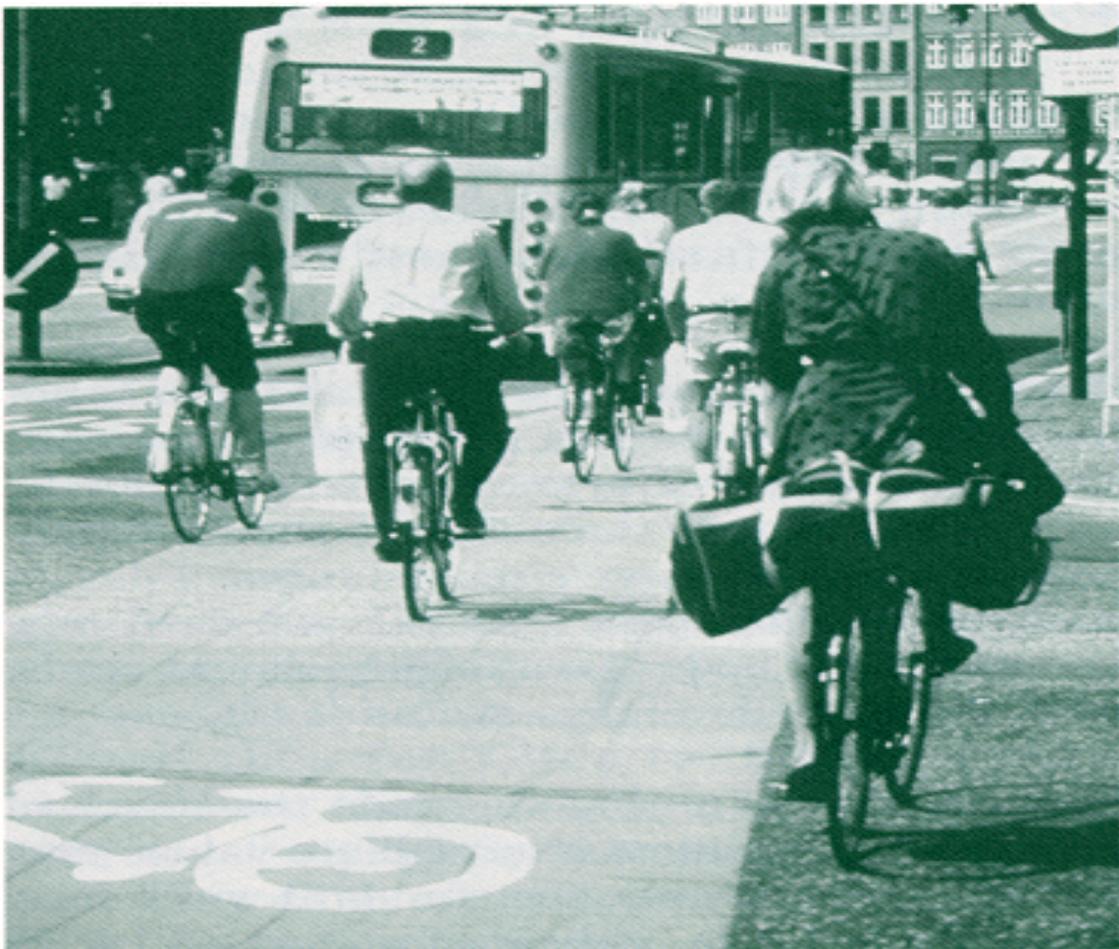
Figure 2. A European raised and painted bike path (crossing).
Source: Oregon Bicycle and Pedestrian Plan, 1995

A raised and painted bicycle path or crossing (figure 2) introduced at 44 intersections in Gothenburg,

Sweden, reduced motor vehicle speeds by 35 to 40 percent for right-turning motor vehicles and increased bicyclist speeds by 10 to 15 percent. The safety improvement was

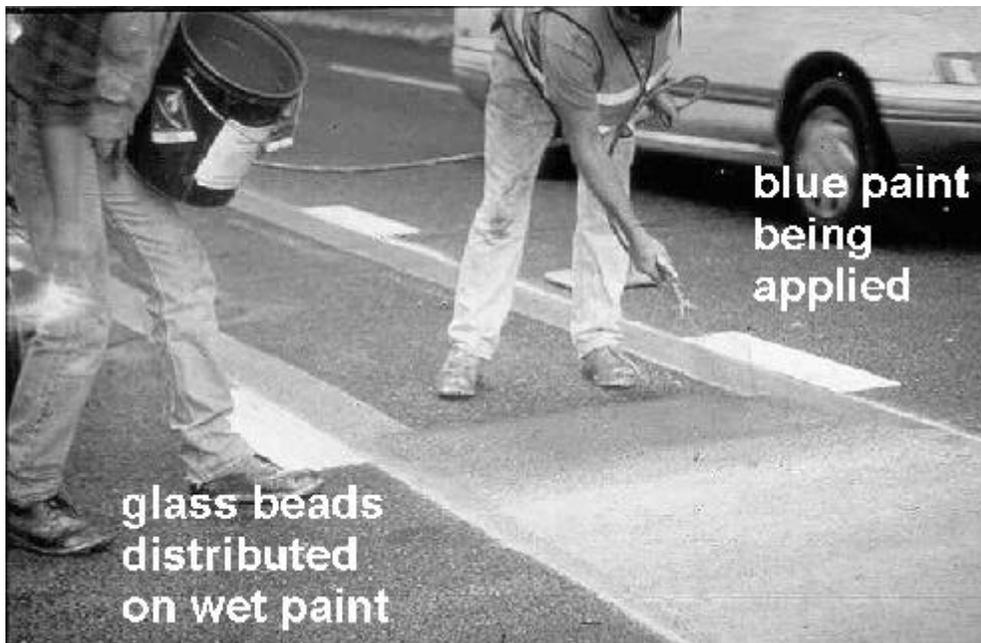
Figure 6. Blue paint and glass beads being applied to one of the conflict areas.

With respect to the materials, both paint and thermoplastic were used. The initial set of markings were painted with glass beads placed on the surface as the paint was being applied (figure 6). The

total cost, including materials and labor, for applying the paint was approximately \$900. Unfortunately, the material lasted only a short time. Within a matter of 2 to 3 months, it was worn away at some of the locations with high traffic volumes. Thus, for the second round of treatment, a thermoplastic material that was skid-resistant was selected and applied at eight locations. The cost for this application included \$9,700 in materials and \$6,300 in labor. While the initial thermoplastic application is significantly more expensive, the life-cycle costs may be worth the investment if one were to factor in the number of times paint would have to be reapplied to maintain the same level of retroreflectivity. Almost a year after the thermoplastic was applied at the eight sites, six of the locations showed very little wear, one was in fair condition, and the other was in poor condition. The latter is believed to be due to incorrect installation. Neither the paint nor the thermoplastic was found to be slippery; however, neither material was as visible as had been expected. The slipperiness was tested by wetting both paint and thermoplastic surfaces and having City of Portland staff perform bicycle test rides. Portland also has an extensive
