The Effects on Safety of In-Roadway Warning Lights at Crosswalks: Novelty or Longevity?

Gabriel Rousseau, Ph.D., Sheryl Miller Tucker, Ph.D., and Ann Do

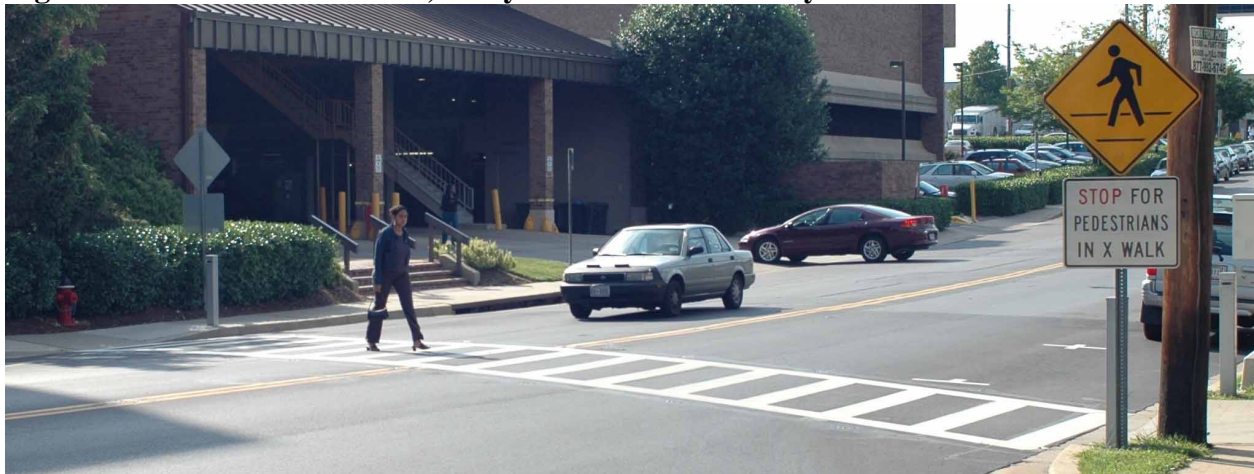
The test site used in this project was in Rockville, Maryland near a Metro Station entrance. The site is pictured below in Figure 1. The crosswalk traverses a two-lane road with street side parking allowed on each side. The crosswalk lacks stop control and the speed limit is 25 mph. On the Metro side of the road (i.e., the right side of the photograph in Figure 1), just before the crosswalk, there is an intersection for buses to turn onto the roadway. A hotel is on the opposite side of the crosswalk (i.e., the left side of Figure 1) from the Metro station. The in-roadway lighting system installation involved: two passive detection bollards on the edge of the curb at either end of the crosswalk, seven lights on each side of the crosswalk, and a series of four lights in the center line as a vehicle approaches to the crosswalk from either direction. The series of four lights are each spaced about 15 feet apart and light up in sequence to draw attention to the crosswalk. The lights along the crosswalk blink on and off at the same rate.

Figure 1. View of the Rockville, Maryland Crosswalk Study Location.

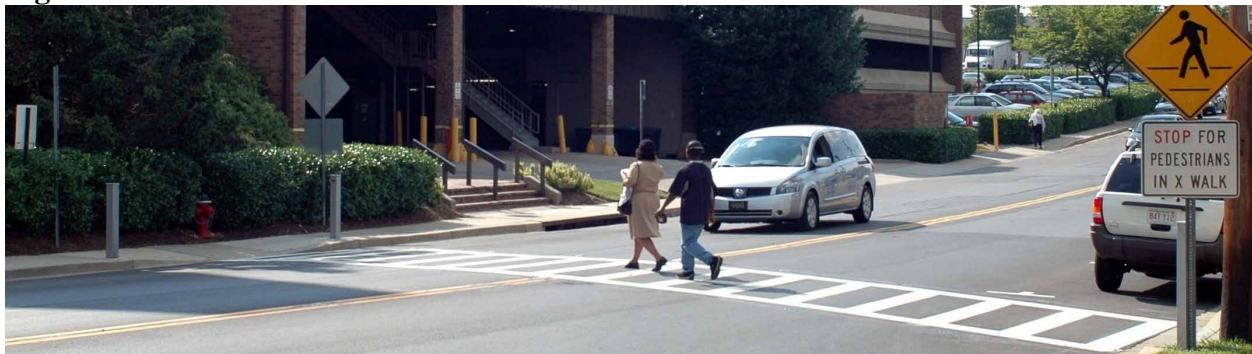
Figure 2. A Driver Waits For Pedestrians To Cross After Treatment Installation.

Note: This is an example of pedestrians completing a near side crossing and a driver yielding to them on the far side.

As can be seen in Table 1, there was a significant increase in driver yielding in the after period when the lights came on. In general, the before data and the after data with no lights look quite similar. Therefore, in-roadway lighting does increase the likelihood that drivers will yield. For both the near and far side lanes, there was roughly a 30 percent increase in driver yielding compared to the two control conditions. The most impressive aspect of these data is that driver yielding on the far side (i.e., once the pedestrian had already traversed one lane) was close to 100 percent. The benefits of the lights are also evident in the decline in the average number of cars that passed a pedestrian and in the reduced pedestrian wait times. All of the differences described were statistically significant. Figure 2 depicts a driver who has yielded to pedestrians crossing from the Metro station. (Note that although not visible in this photograph, the in-roadway lights were on and were visible to the driver).
